Collapsing Soil—a Geologic Hazard

by Bruce J. Murphy

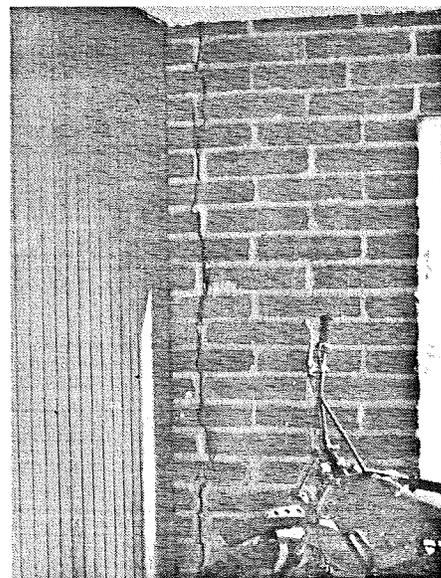
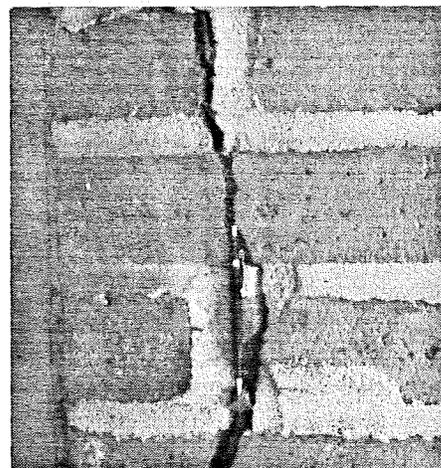
These photos of a house's brick wall show tensional cracks with up to 1-inch displacement.

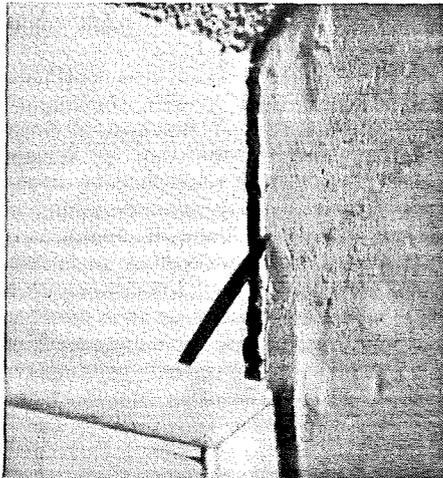
Top: vertical and lateral displacement is caused by settlement.

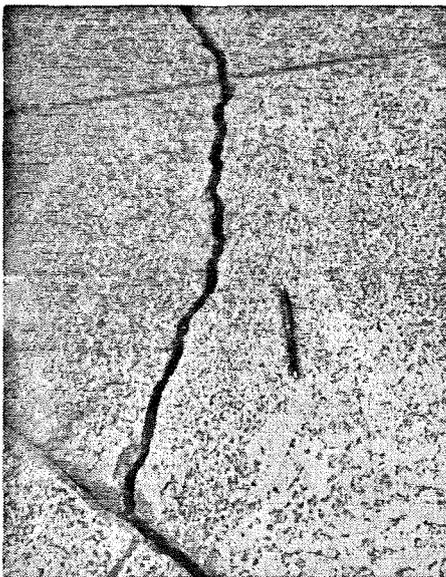
Bottom: patio floor was extensively damaged by differential cracking.

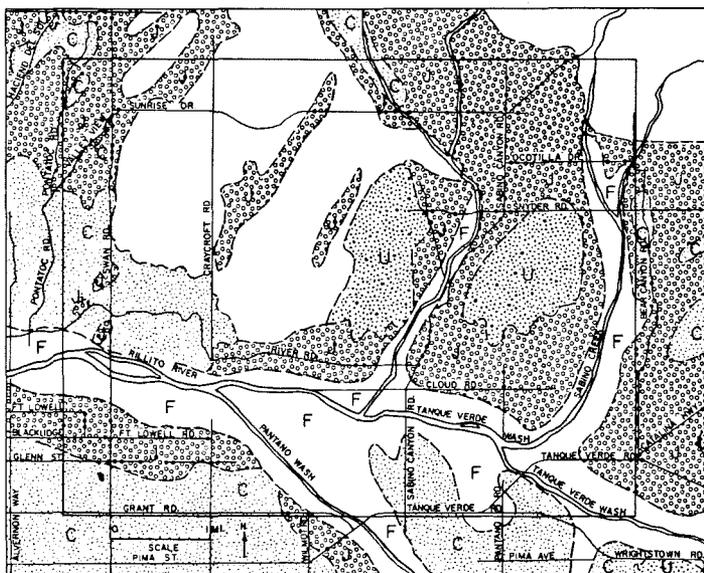
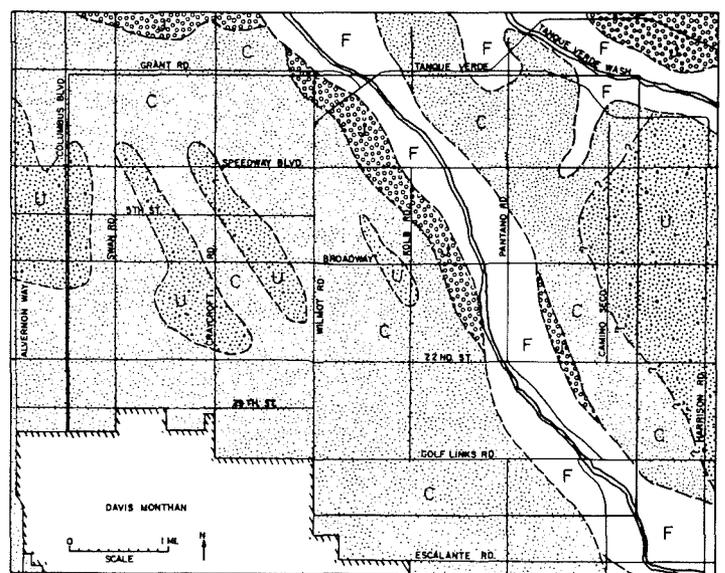
These maps are of terraces and erosion surfaces within the Tucson area. The Cemetery unit appears to have the greatest potential for foundation failure.
