Arizona Geology

Vol. 34, No. 3
FALL 2004

Fire and Sediment Deposition

Philip A. Pearthree
Arizona Geological Survey

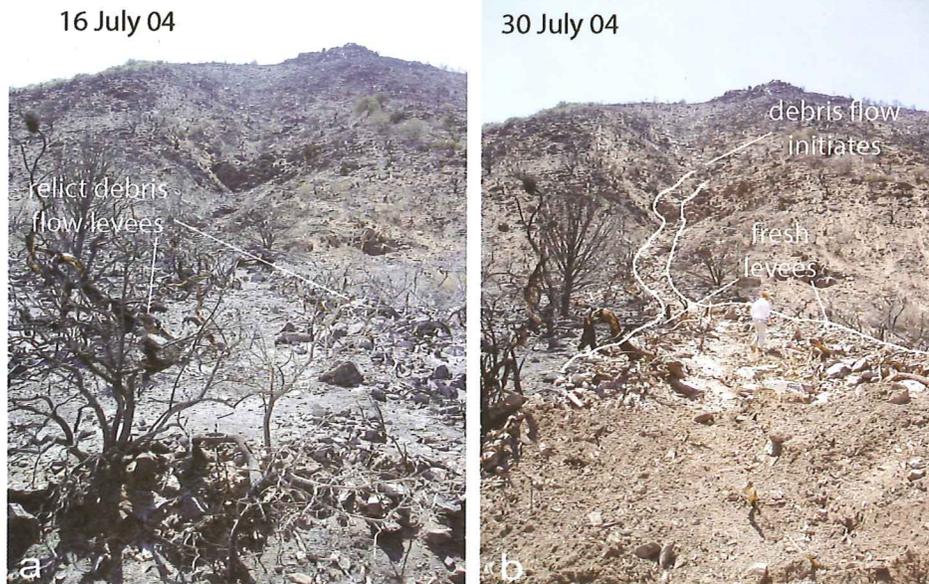
Figure 2. a) Photograph of a small wash near SR 87 taken just after the Willow Fire. b) Photograph of the same wash taken a few days after a heavy rain fell July 23, 2004.

During our field survey of fire-related hazards, we found evidence that debris flows had occurred in the past on two small drainages near SR 87 (Figure 2). The hillslopes and channels of these drainages are very steep, and the watersheds were devoid of living vegetation after the fire. As these channels exit the mountains, they spill out onto small, cone-shaped

alluvial fans. Unfortunately, the southbound lane of SR 87 is cut into the toes of these fans. We observed parallel alignments of boulders and boulder piles on the fans that are typical of deposits left by debris flows.

On the evening of July 23, an intense thunderstorm occurred in this part of the burned area. All of the larger drainages that cross under SR 87 experienced substantial floods, but none overtopped the highway. Debris flows occurred in many small, steep drainages, including the two that we had identified as representing a potential hazard. These debris flows developed in steep channel reaches, picked up many boulders as they headed down the channels, and spilled out onto and across the alluvial fans. One of the flows covered the southbound lane of SR 87 (Figure 3). Most of the boulders carried by the debris flows were deposited on the fans, adding to the levees and boulder piles that existed prior to the recent events. The Arizona Department of Transportation quickly cleaned up the debris.

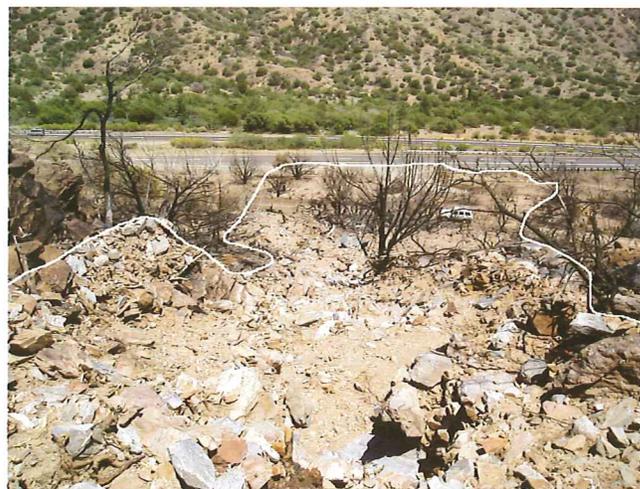
Figure 3. The debris flow that moved along this small channel reached the ditch of SR 87 and lapsed onto the edge of the highway. The debris flow in the next drainage to the north crossed the highway

The important question for the near future is whether more debris flows will impact SR 87 in this area. The potential for enhanced runoff will exist in the burned watersheds for several years, at least. Because so much sediment was removed from the channels that produced debris flows, decades or centuries will probably pass before sufficient sediment accumulates to sustain another debris flow in these watersheds.
