# Arizona Geological Survey ARIZONA GEOLOGY

Vol. 23, No. 2

## The Arizona Floods of January and February 1993

*P. Kyle House*  
Arizona Geological Survey

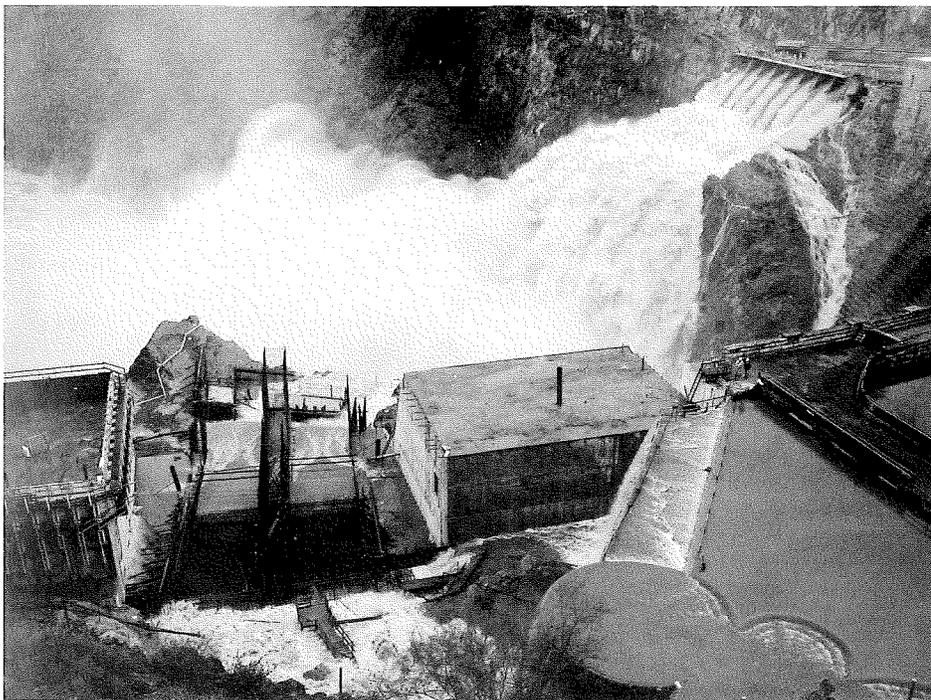
*Figure 1. Close-up of the Roosevelt Dam spillway on January 19. The combined discharge of the Salt River over the spillway and coffer dam (foreground) was approximately 34,000 cubic feet per second (cfs) at the time the photograph was taken. This value is associated with the highest recorded level of Roosevelt Lake. The flooded area in the foreground is the construction site of a new spillway. Photo courtesy of the U.S. Bureau of Reclamation.*

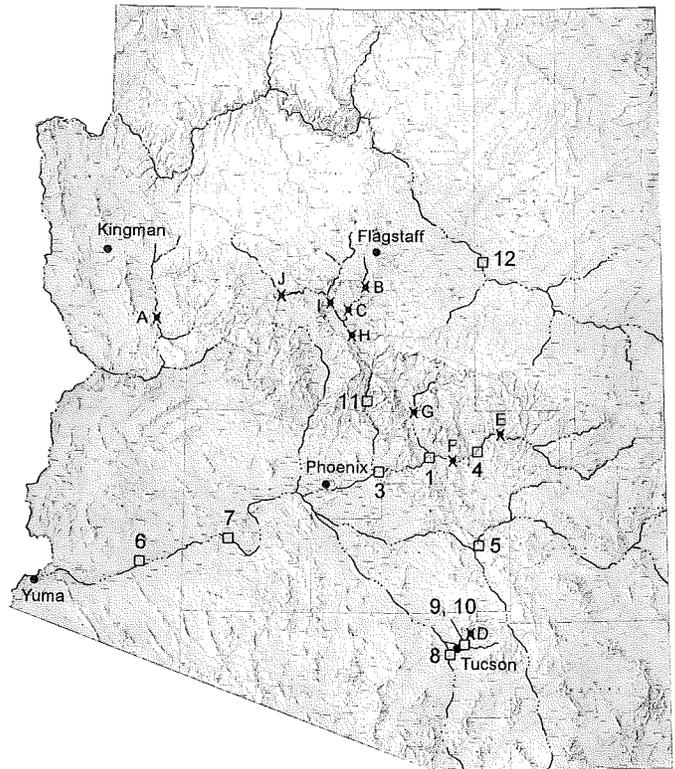
Figure 2. Major streams, approximate sites of Figures 1 through 12, and locations of lettered stream gages listed in Table 1.

Table 1. Record floods in Arizona during the winter of 1993. Locations of gages are identified by letter on Figure 2. Discharge estimates for 1993 were supplied by the U.S. Geological Survey and are considered preliminary and subject to revision.

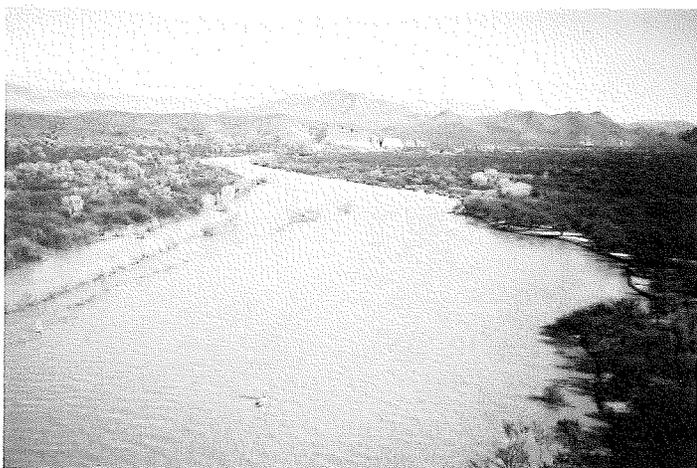
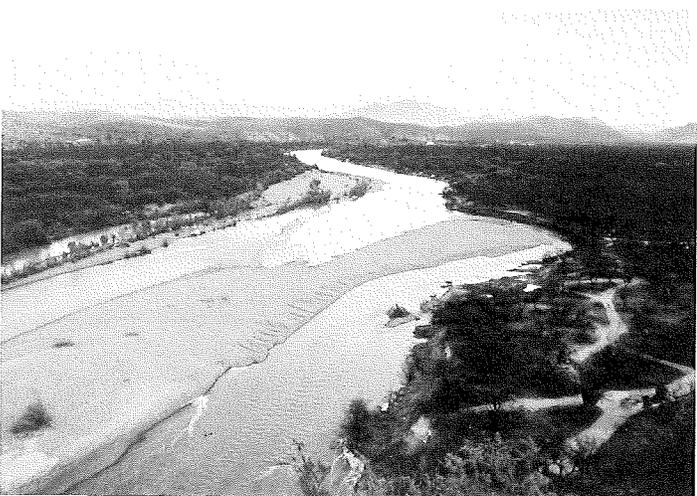
**Figure 3 (a and b).** Salt River below Stewart Mountain Dam. The first photograph was taken on January 20 following a peak discharge of 41,000 cfs. The second photograph of approximately the same site was taken on March 10. The peak discharge through this reach of the Salt River was significantly attenuated by storage upstream in Saguaro, Canyon, Apache, and Roosevelt Lakes. Photos by P. Kyle House, Arizona Geological Survey.

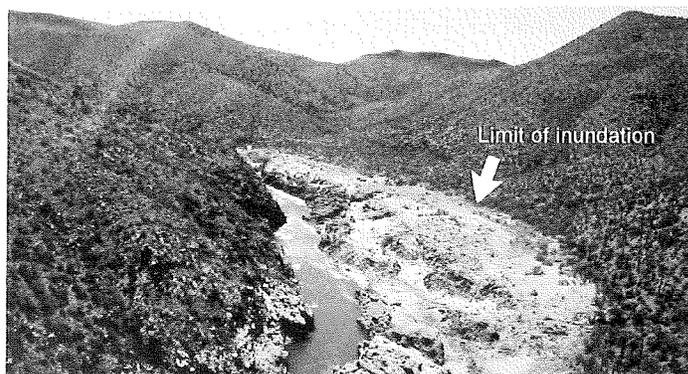
**Figure 4 (top).** View of the Salt River in Jump Off Canyon above Roosevelt Lake. A flood discharge of approximately 144,000 cfs passed through this reach on January 8. The flood removed all vegetation, soil, and weathered bedrock from the canyon walls and from the bedrock bench on the right bank. The flow depth exceeded 40 feet at this site. Photo by P. Kyle House, Arizona Geological Survey.

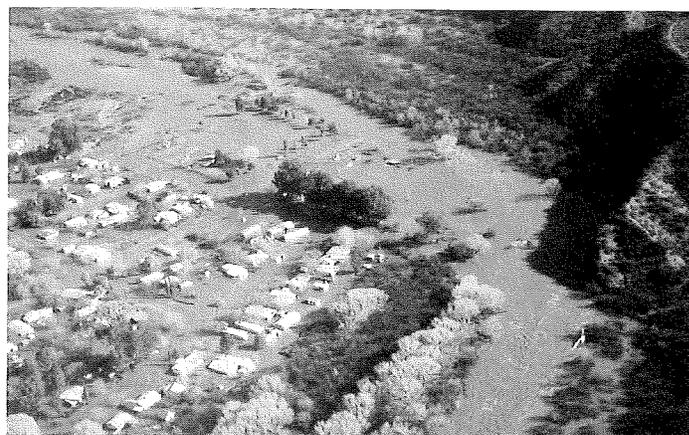
**Figure 5 (bottom).** Aerial view of the Winkelman Flats in Winkelman, showing inundation by the Gila River below Coolidge Dam. This photograph was taken on January 20. The peak discharge on the Gila River 20 miles downstream at Kelvin reached 74,200 cfs on the afternoon of January 19. Photo by Victor R. Baker, University of Arizona.

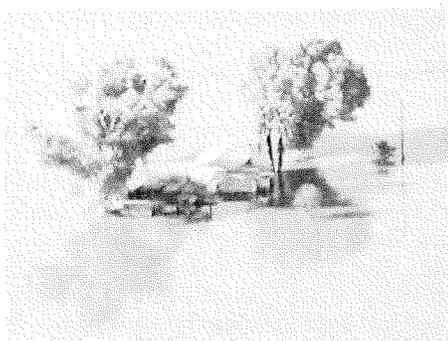
**Figure 6 (above).** Flooded agricultural land along the lower Gila River. This photograph was taken on March 3. This flood resulted from unprecedented releases (peak discharge: 25,920 cfs) from Painted Rock Reservoir. Photo © 1993 Peter L. Kresan, University of Arizona.

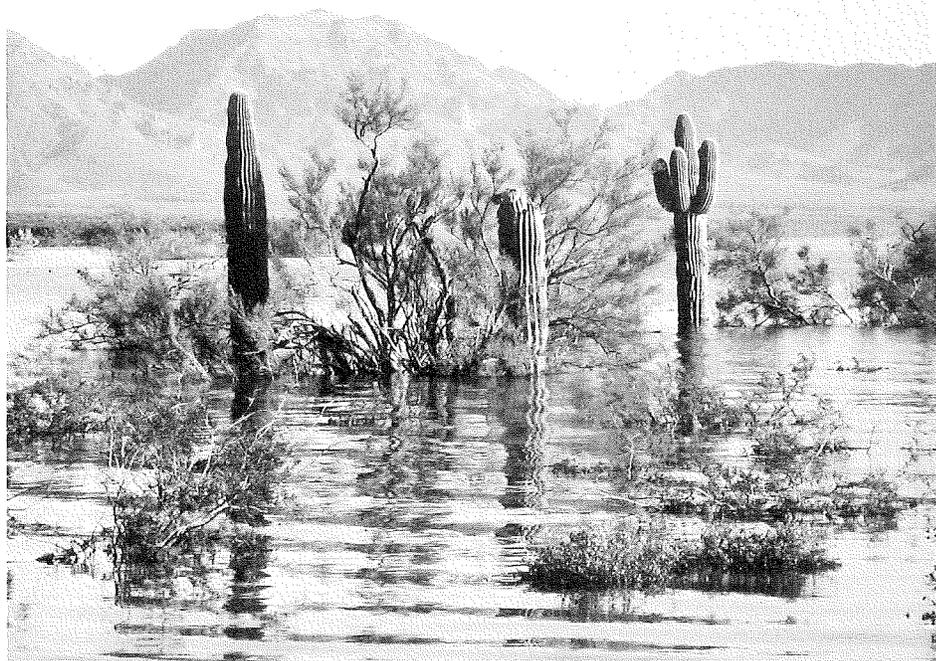
**Figure 7 (right).** Native Sonoran Desert vegetation flooded along the margins of Painted Rock Reservoir in southwestern Arizona. This reservoir, fed by the Gila River, filled to a capacity of 2.8 million acre-feet for the first time since its completion in 1961. Photo taken on March 16 by Steven J. Skotnicki, Arizona Geological Survey.

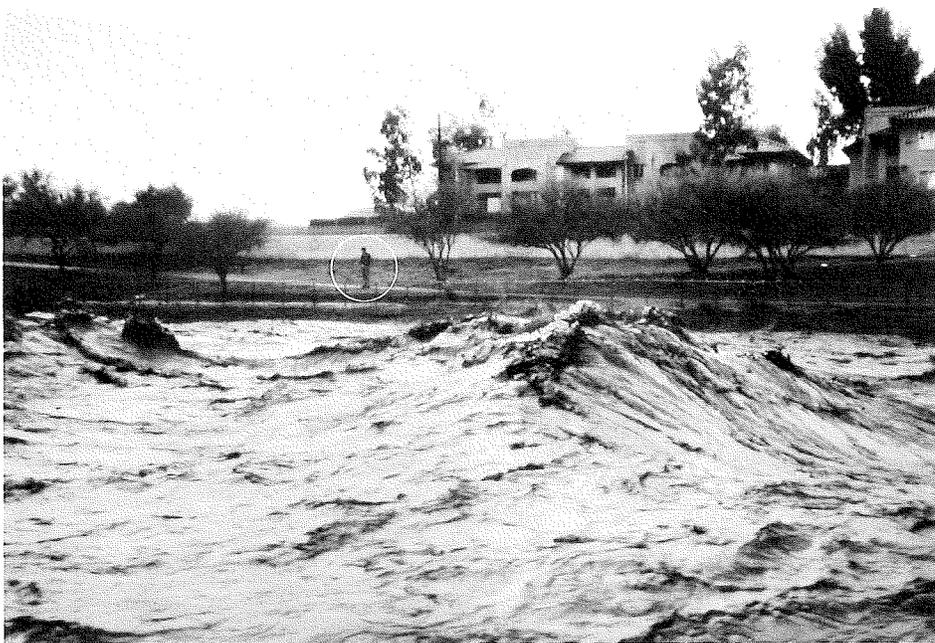
**Figure 8 (above).** Large standing waves on the Santa Cruz River near downtown Tucson. This photograph was taken on January 19 at approximately 9:30 a.m. The peak discharge in this reach was between 25,000 and 35,000 cfs that morning. Photo by P. Kyle House, Arizona Geological Survey.

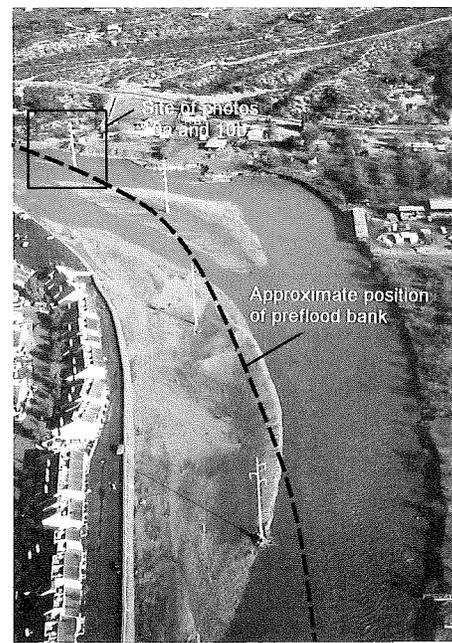
**Figure 9 (above).** Severe bank erosion along Rillito Creek near N. Country Club Blvd., Tucson. This photograph was taken on January 20, 12 days after the peak discharge. Line on photo shows former position of bank. Photo by Victor R. Baker, University of Arizona.

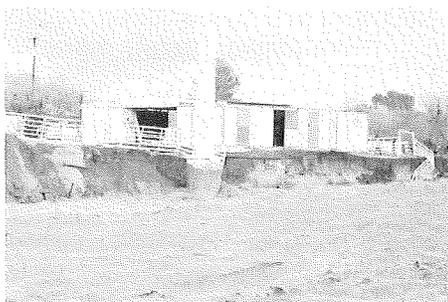
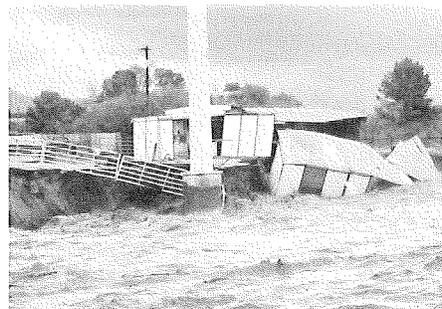
**Figure 10 (a and b, left).** Sequential photographs of site within Figure 9 showing horse stables being destroyed by bank erosion along Rillito Creek near N. Country Club Blvd., Tucson. The photos were taken at 11:33 a.m. and 11:50 a.m. on January 8. The peak discharge on Rillito Creek was between 20,000 and 30,000 cfs earlier that morning. Photos by H. Wesley Peirce, Arizona Geological Survey.

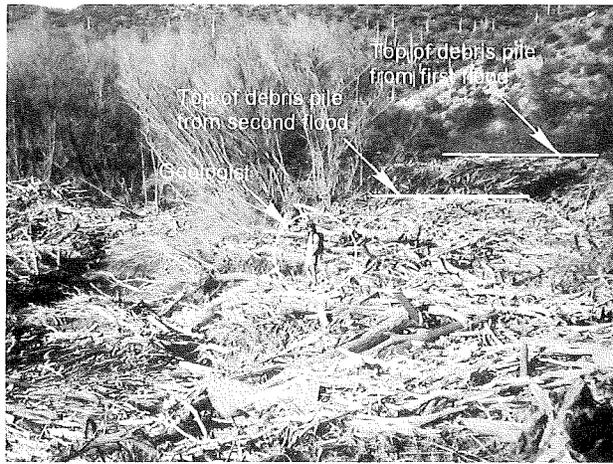
Figure 11. Massive pile of flood debris on the lower Verde River above Horseshoe Reservoir. This photograph, taken on April 10, shows two levels of debris that correspond to the peak discharges of January 8 (127,000 cfs) and February 20 (111,000 cfs). Note arrow pointing to person for scale. Photo by Philip A. Pearthree, Arizona Geological Survey.

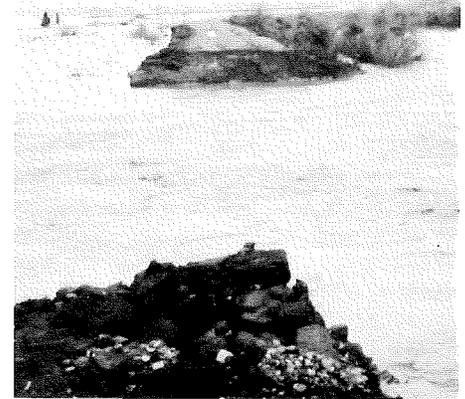
Figure 12. Breach in an artificial levee on the Little Colorado River near Winslow on January 7. The breach was closed on January 14 before another series of storms caused flooding that came within 2 feet of the crest of the repaired levee. Photo by Chuck Williams, Navajo County Flood Control District.
