Geologic Hazards in the Phoenix Area

By Troy Péwé

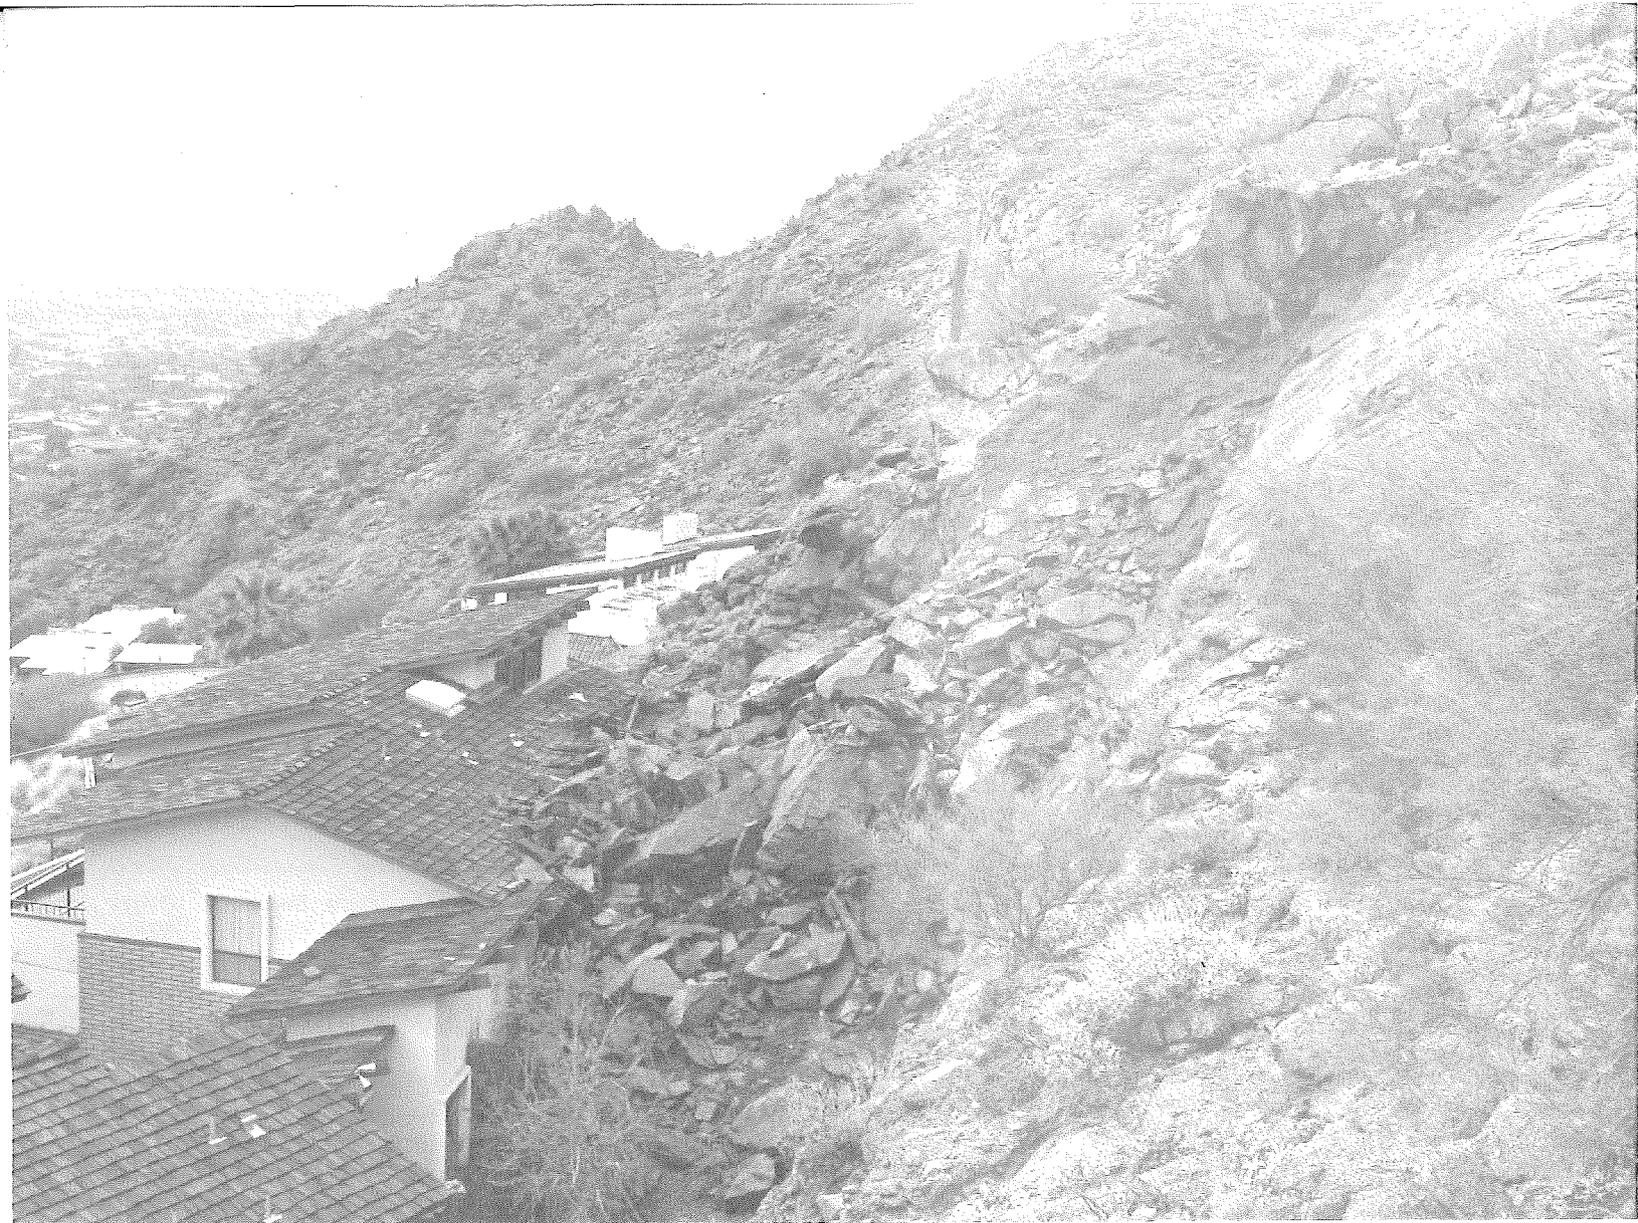
Above; Home on granite bedrock on south side of Camelback Mountain, Phoenix, Arizona, partially destroyed by rock slide after several weeks of above normal precipitation. (Photograph by T.L. Péwé March 2, 1978.) Right; Detail of above rock slide.

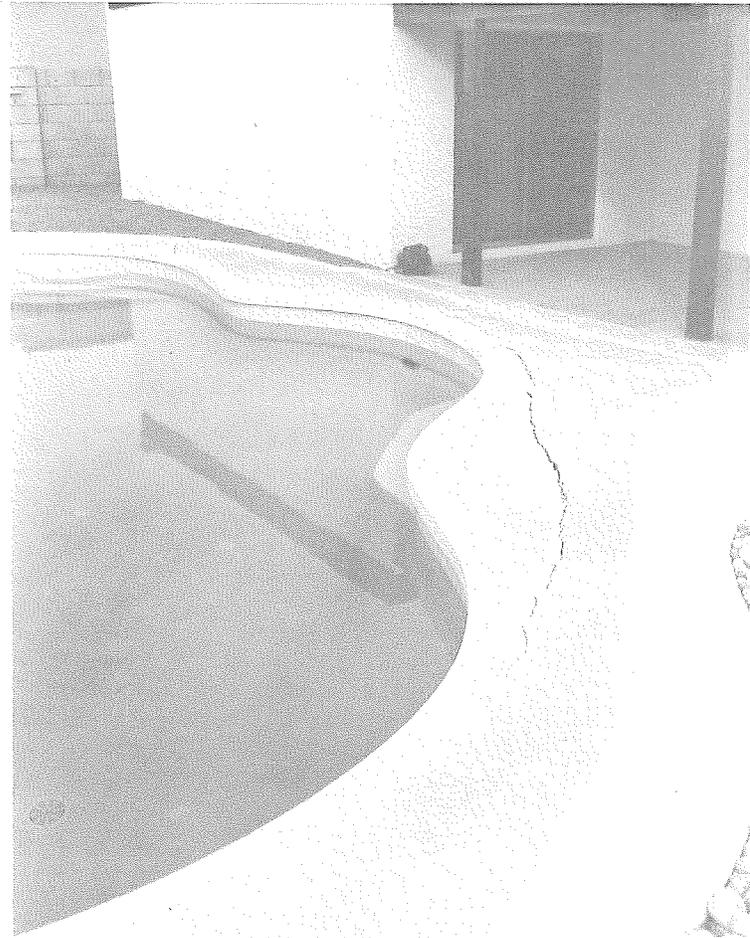
Right; Crack in deck of swimming pool due to clay swelling in foundation soils. Vertical displacement 1 cm. at this time. Similar cracks occur elsewhere in deck; four cracks are below water line. Pool, located at the McCormick Ranch in Scottsdale, Arizona, was constructed three to four months earlier. (Photograph by T.L. Pewe, January 6, 1978.)

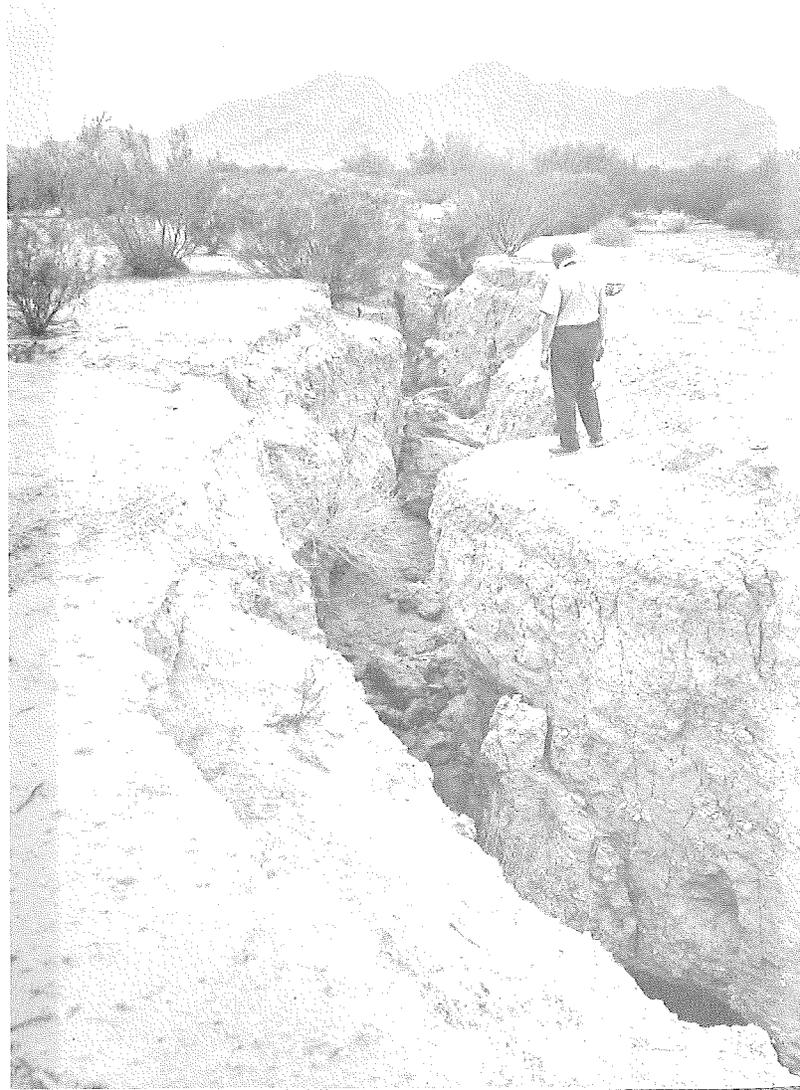
Below, rt; Earthquake located on the south side of Chandler Heights on Hunt Road, 1¼ miles east of Powers Road on the boundary between Maricopa and Pinal counties. Earthcracks are caused by land subsidence, the result of ground-water withdrawal. The San Tan Mountains are in the background. The crack is open to at least a depth of 50 feet. (Photograph by T.L. Péwé, July 25, 1972.)

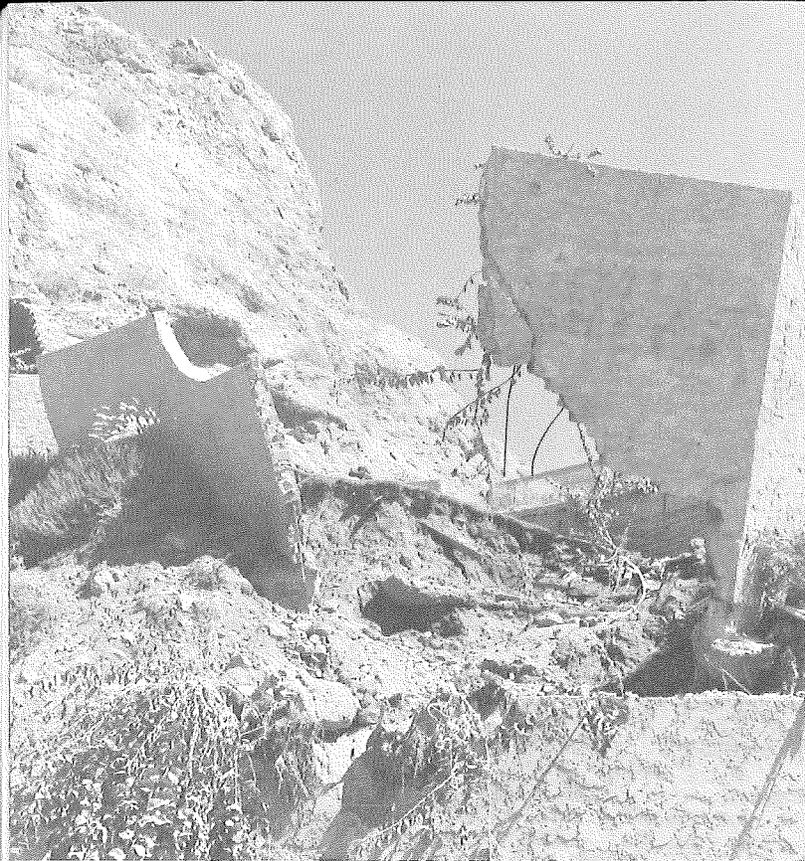
Left; Detail of mud slide below. (Photograph by T.L. Péwé, September 9, 1978.)

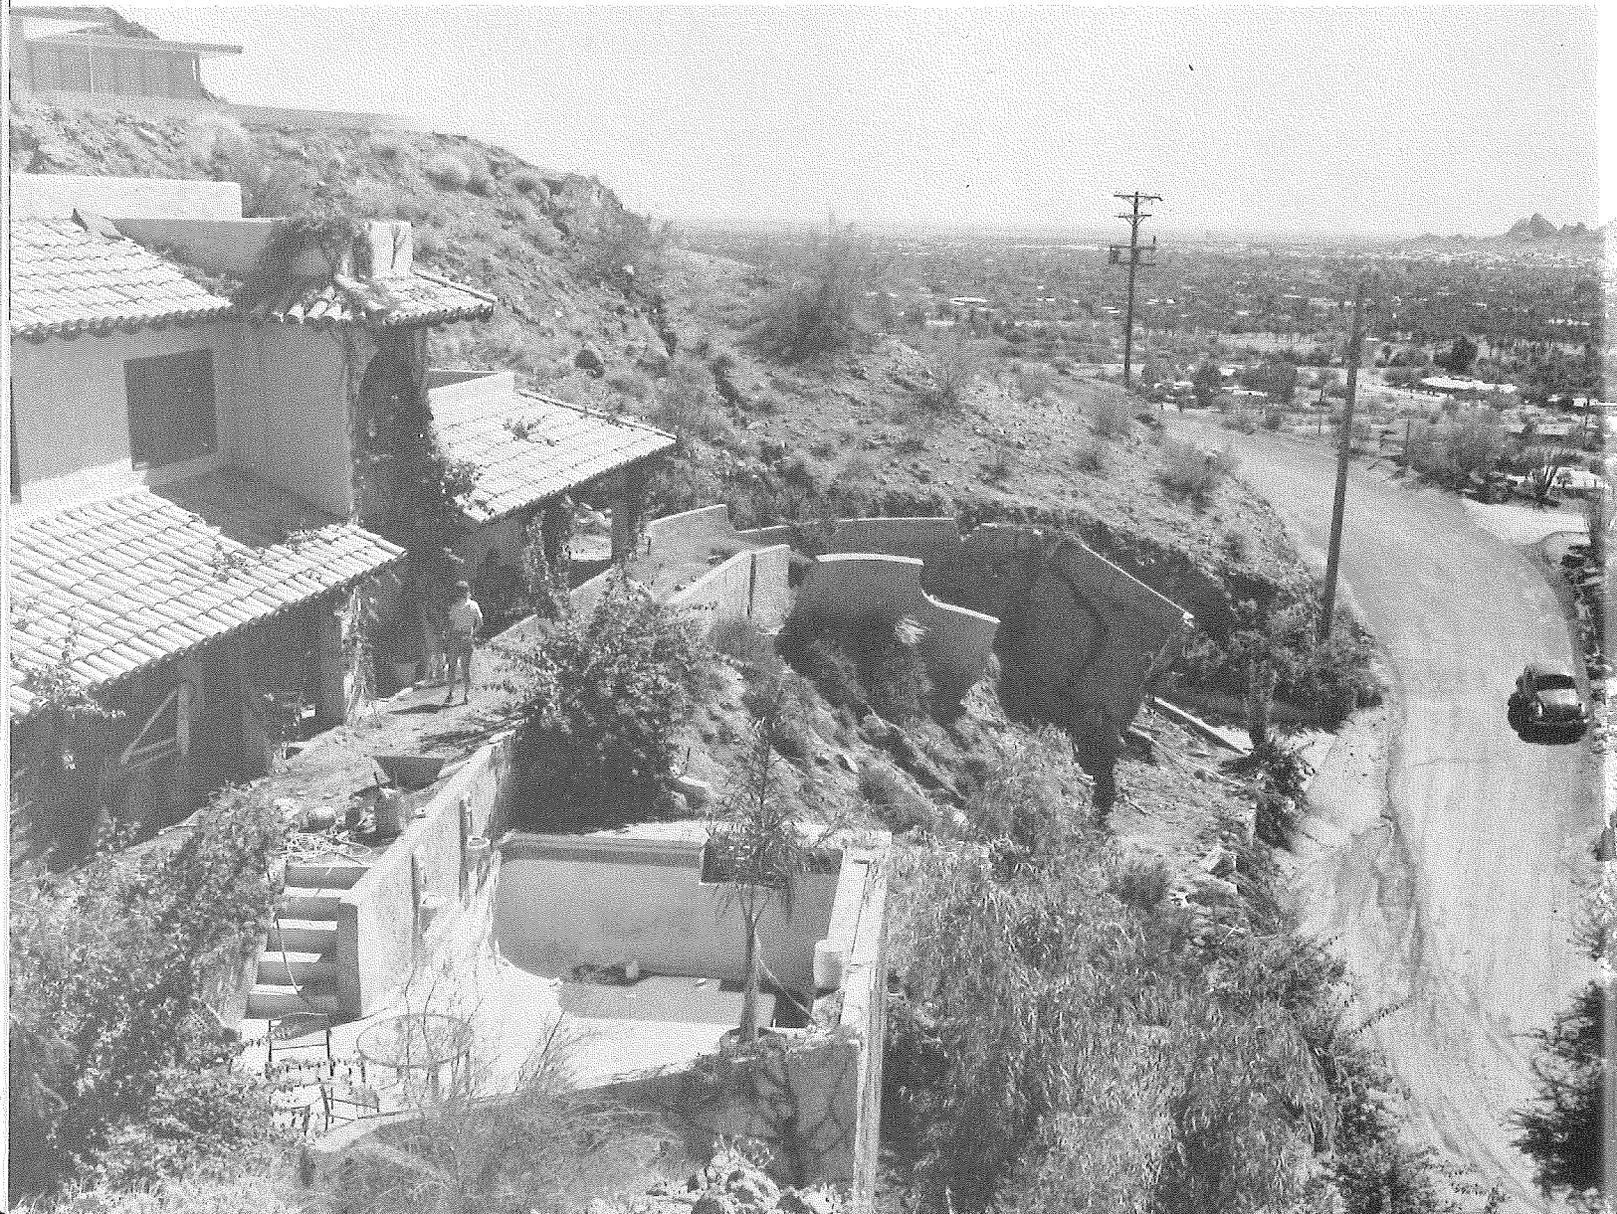
Below; Home of the south side of Camelback Mountain, Phoenix, Arizona, partially destroyed by mud slides during intense rainstorm. (Photography by T.L. Péwé, September 9, 1976.)
