## PIMA COUNTY MOVES ON GEOLOGIC HAZARDS

By  
H. Wesley Peirce  
Geologist  
John S. Vuich  
Assistant Geologist

# FLOODPLAINS

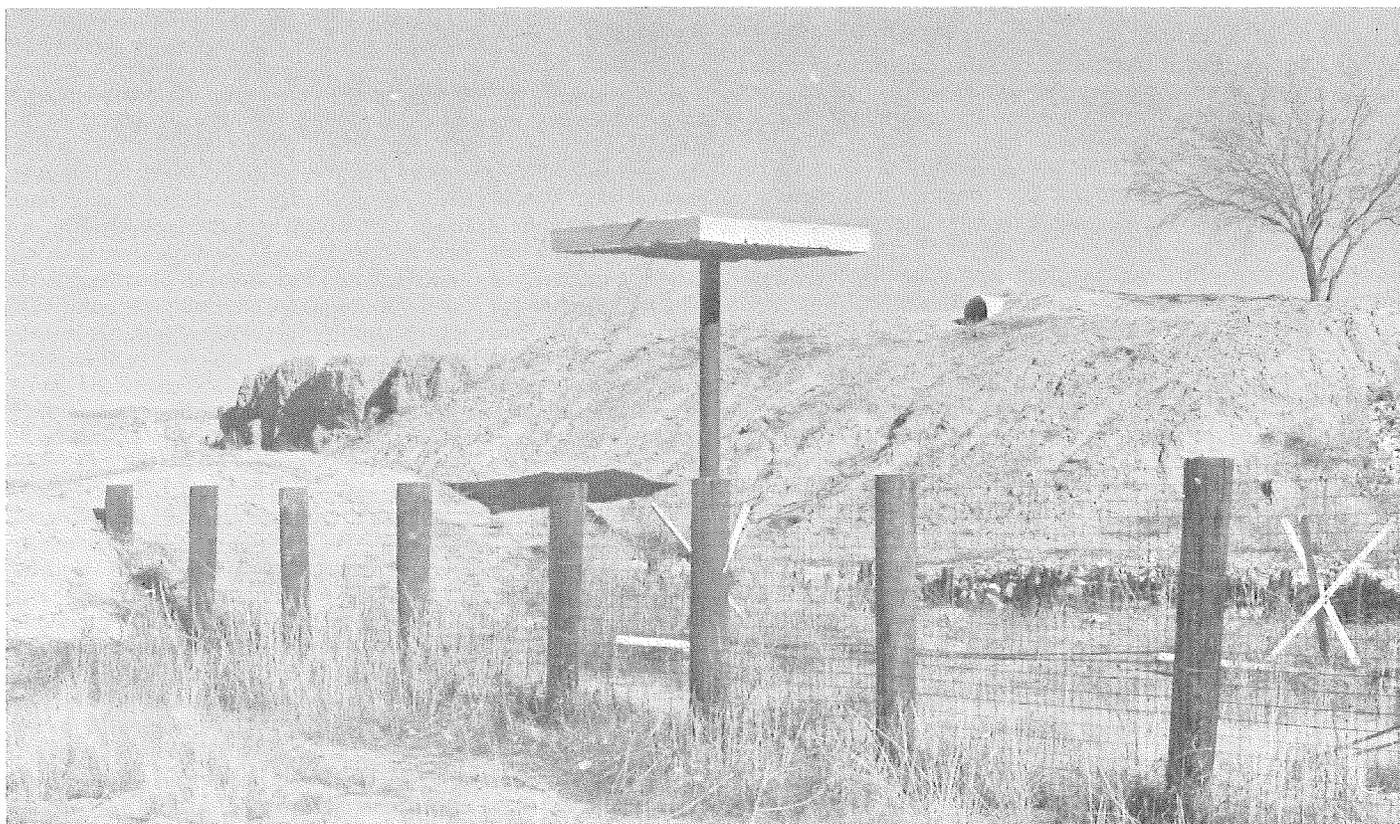
Fig. 1. What happened? Try to explain the position of the concrete slab. There is an answer inside — somewhere. 1975.

The front page puzzlement is the upper part of a water well that has been exposed by bank erosion along the Santa Cruz River. The well was measured in 1963 but not in 1964, for obvious reasons. Data from Jim Posedly - Dept. of Soils, Water and Engineering, Univ. of Arizona.]

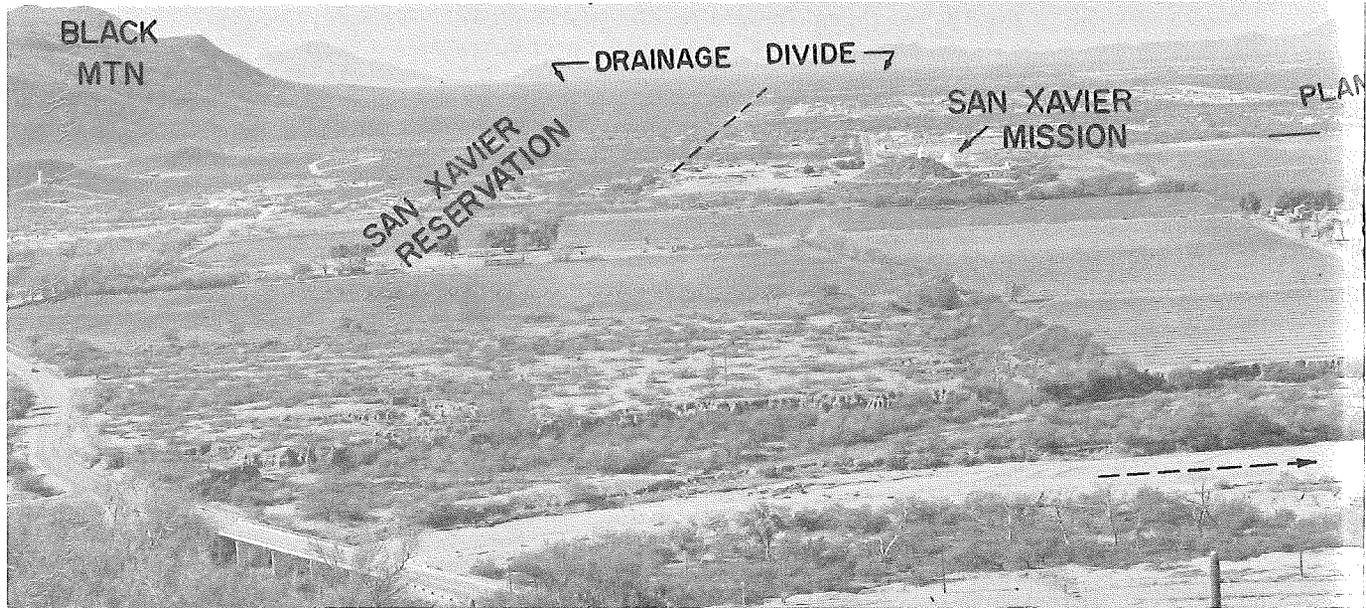
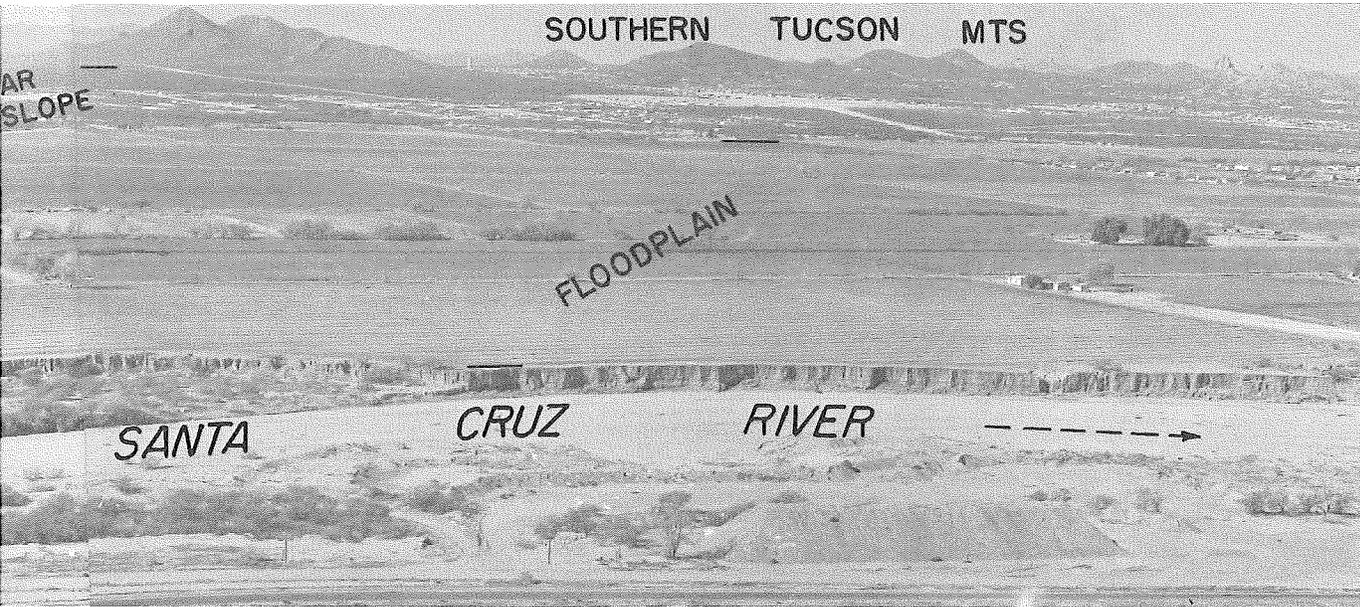
Fig. 2. View westerly toward San Xavier Mission and southern Tucson Mountain region showing: (1) normally dry S by both vegetation contrasts and the degree of secondary erosion of each bank segment (oldest to left), (3) plan (4) scattered development, and (5) isolated bedrock hills (inselbergs) rising from a shallowly buried bedrock sho

Santa Cruz River channel (flows left to right) and adjacent tilled floodplain, (2) three ages of bank erosion as reflected by the slope rising from the floodplain up to the base of the bedrock hills and to a drainage divide between the hills, (3) alluvial fan (FIELDNOTES, vol. 3, no. 4). 1975.

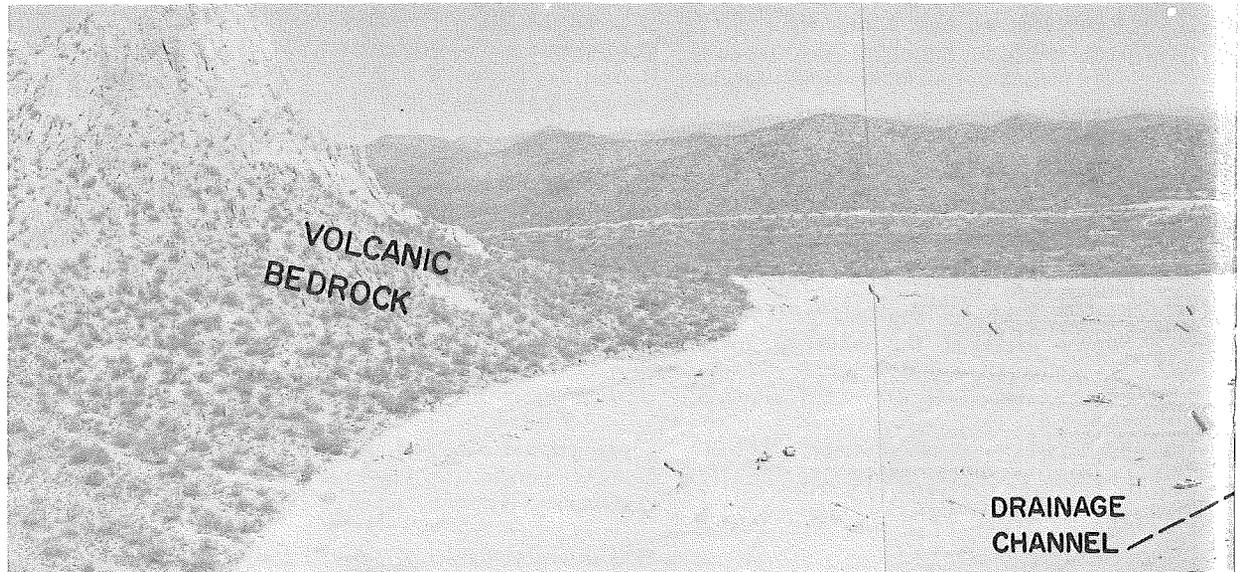
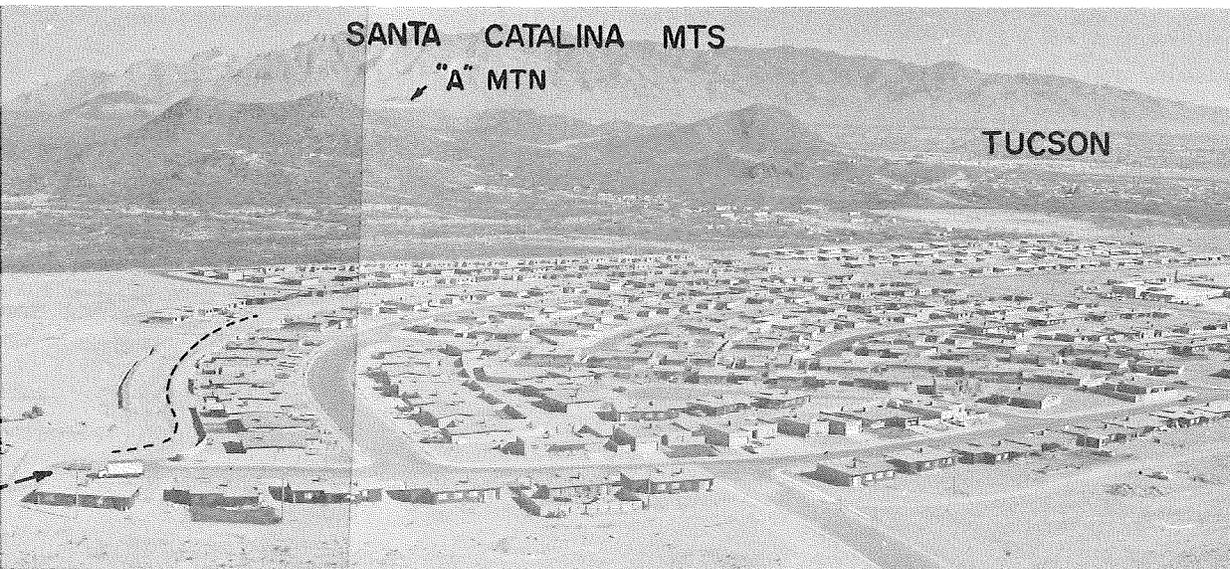
Fig. 3. View northerly from east side of southern Tucson Mountains showing: (1) housing density possible on the upper slope. They are terraces or steps made from leveled fill dirt, (3) residential encroachment into the drainage channel, (4) community is constructed above a shallowly buried bedrock shoulder. 1975.

on relatively undissected planar slopes, (2) building pads being constructed on the undeveloped portion of the hills in middle distance. The elevation change over the upper one mile of slope is about 130 feet. This entire

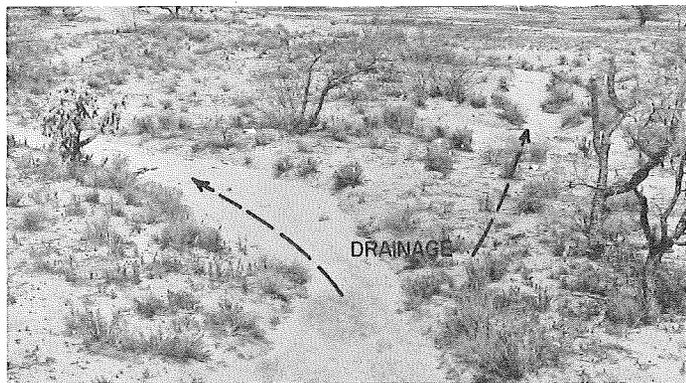
Fig. 4. Shallow, sand-floored (no boulders) drainages characteristic of sheetflood-prone areas that develop on planar slopes surrounding the low-elevation mountain blocks in the desert region. An excess of water spreads out in "sheets." Southern Tucson Mountains region. 1975.

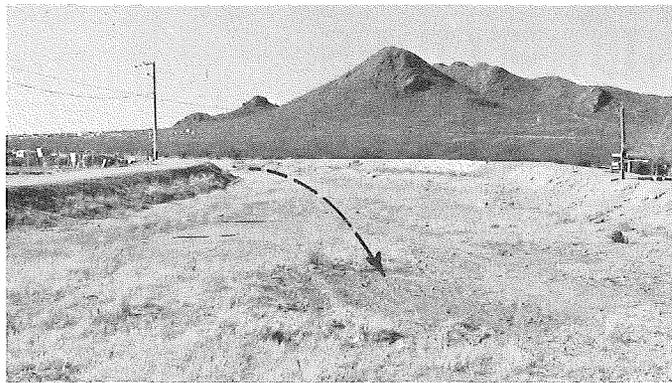
Fig. 5. Man-made drainage system designed to channel sheetflood waters collected by a dike erected on a planar slope at the upper edge of a residential area. Looking westerly, upslope, southern end Tucson Mountains. 1975.

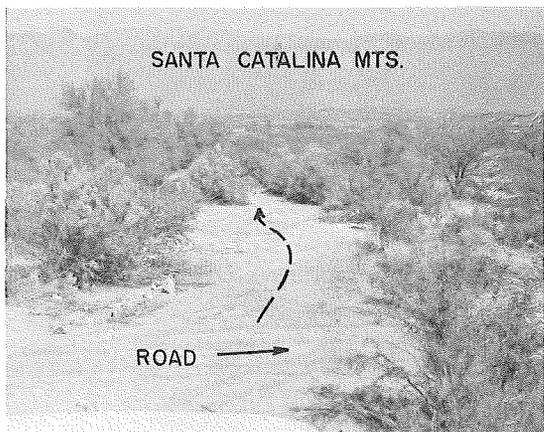
Fig. 6. Looking north down a shallow, sand-filled (no boulders), vegetated "watercourse" (as defined in Floodplain Ordinance) that is subject to overflow, or spreading similar to sheetflooding. Drainage is developed on a planar slope that terminates to the north at the Tanque Verde Wash floodplain. This particular drainage can be traced for over four miles and has an elevation difference of near 400 feet. Late 1973.

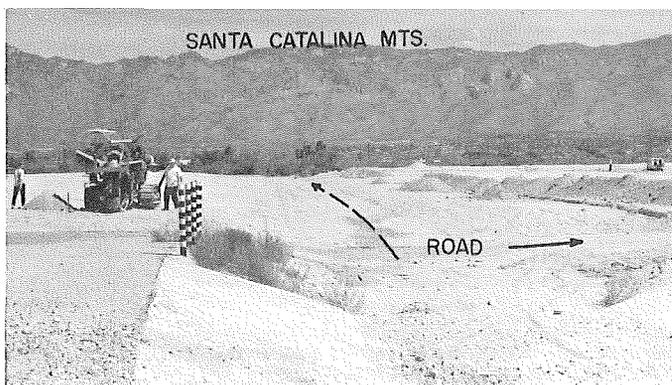
Fig. 7. Same locality as Fig. 6, in late 1974, being prepared for development of a rezoned area in the city. The boundary with Pima County runs left-right near uncleared vegetation downstream. Changes made in the natural watercourse include: (1) straightening, (2) devegetating, and (3) construction of higher confining banks. None of these changes is comforting to the first-come County occupants that are adjacent to the unchanged natural drainage downstream. The new development is tacked onto a previously modified (concrete sides) reach of the watercourse. Much of the upstream area is undeveloped which portends additional future pressure on this piecemealed drainage.

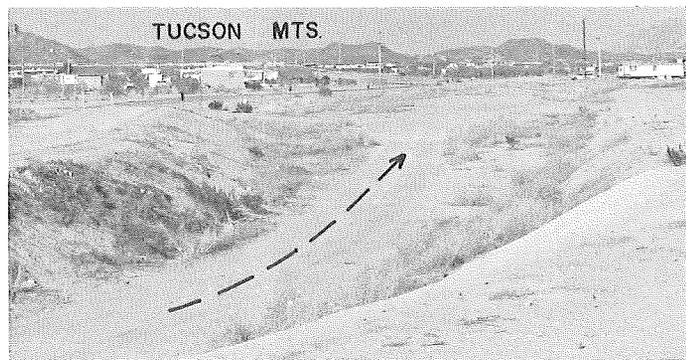
Fig. 8. Terminated lower end of man-made channel created to carry sheetflood flow collected from higher upslope. From here, drainage is less formalized and disgorging waters are less efficiently managed to the detriment of late-coming down-drainage occupants.

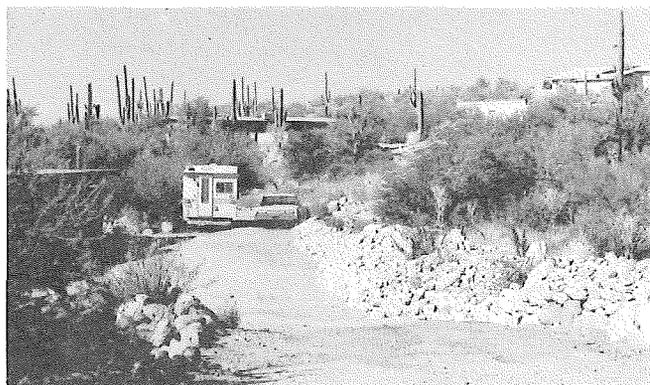
Fig. 9. Catalina foothills resident defends self from low flows that move from right to left. High flows will result in much apprehension. Note boulders here as compared to sand in the lower energy drainages characteristic of the planar slope areas (Figs. 4 and 6.) Hopefully, by sensitive application of the new Floodplain Ordinance that pertains to watercourses, County officials will be able to minimize such conflicts in the future. Incidentally, owner did not know what he was getting into. This drainage rises over 4,000 feet above this point. No wonder there are boulders! 1973.

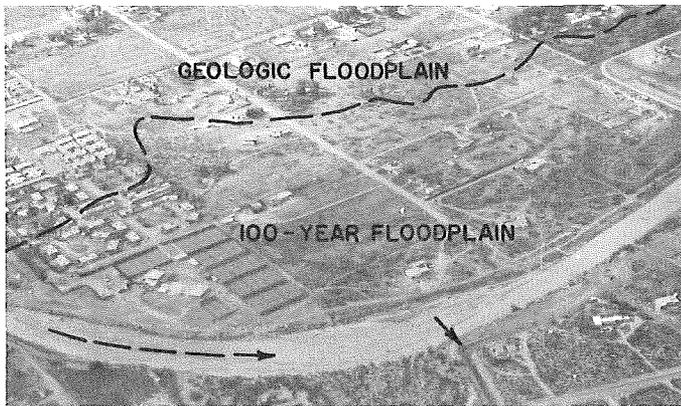
Fig. 10. Looking southwest across Rillito River channel (flows left to right) onto floodplain surface that is subdivided into the 100-year floodplain and the geologic floodplain. Although the north bank (near side) is high, it is the bank subject to erosion. The new sewer line route is shown. (See Fig. 13.) At its closest point to the eroding bank (arrow), the center line of the sewer is at the same elevation as the river bottom. This positioning is a function of right-of-way considerations. 1973.

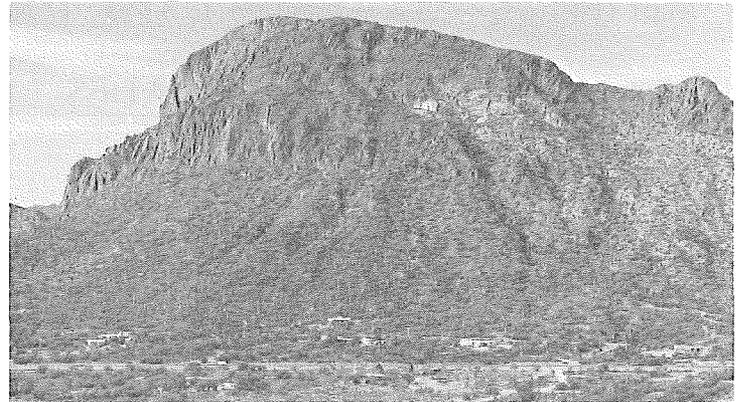
Fig 11. Dwellings near base of steep slope, below cliffs of 65-million-year-old Cat Mountain Rhyolite. Relief is over 1,000 feet. Fracturing divides rock into blocks, some of which have rolled beyond dwellings. Ajo road in foreground — looking northwest. Pima County is reviewing this type of natural hazard. 1975.

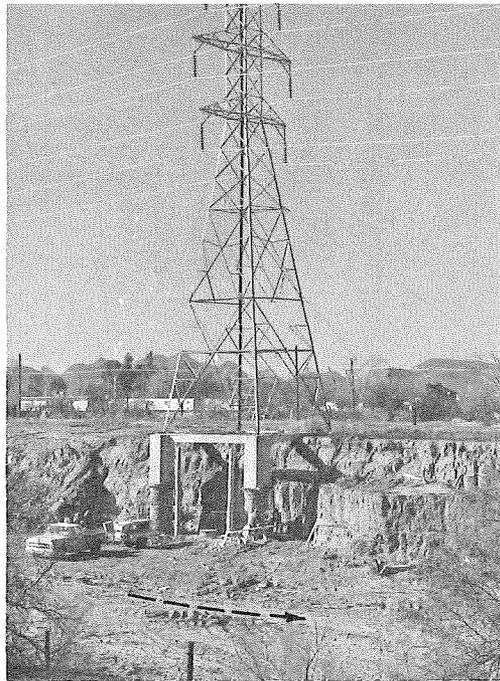
Fig. 12. Bank erosion along Santa Cruz River exposes supports for pillars holding up tower. Workers undertaking repairs. 1975.

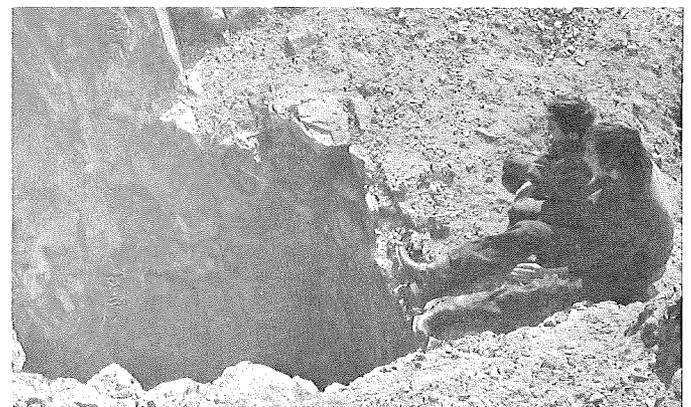
Fig. 14. A cautious look at an abandoned prospect pit (30 feet deep) in Saginaw Hill mineralized area of the southwestern Tucson Mountains. 1975.

Although not a natural hazard, frequently, near bedrock outcrops such as along the Catalina-Rincon front and various places in and near the Tucson Mountain area, etc., prospecting activity has resulted in various holes and pits that, in some cases, remain as unprotected, attractive hazards. Population expansion has resulted in residential encroachment into these once remote locations. The State Mine Inspector has the authority to order property owners of record to fence, post, and/or cover these man-made dangers. Any citizen has the right (duty?) to notify the Inspector of anything of this sort that is considered dangerous to the curious, young or old!
