# Earth Fissure Map of the Chandler Heights Study Area: Pinal and Maricopa Counties, Arizona

February 2008  
Arizona Geological Survey

## Digital Map Series - Earth Fissure Map 1 (DM-EF-1)

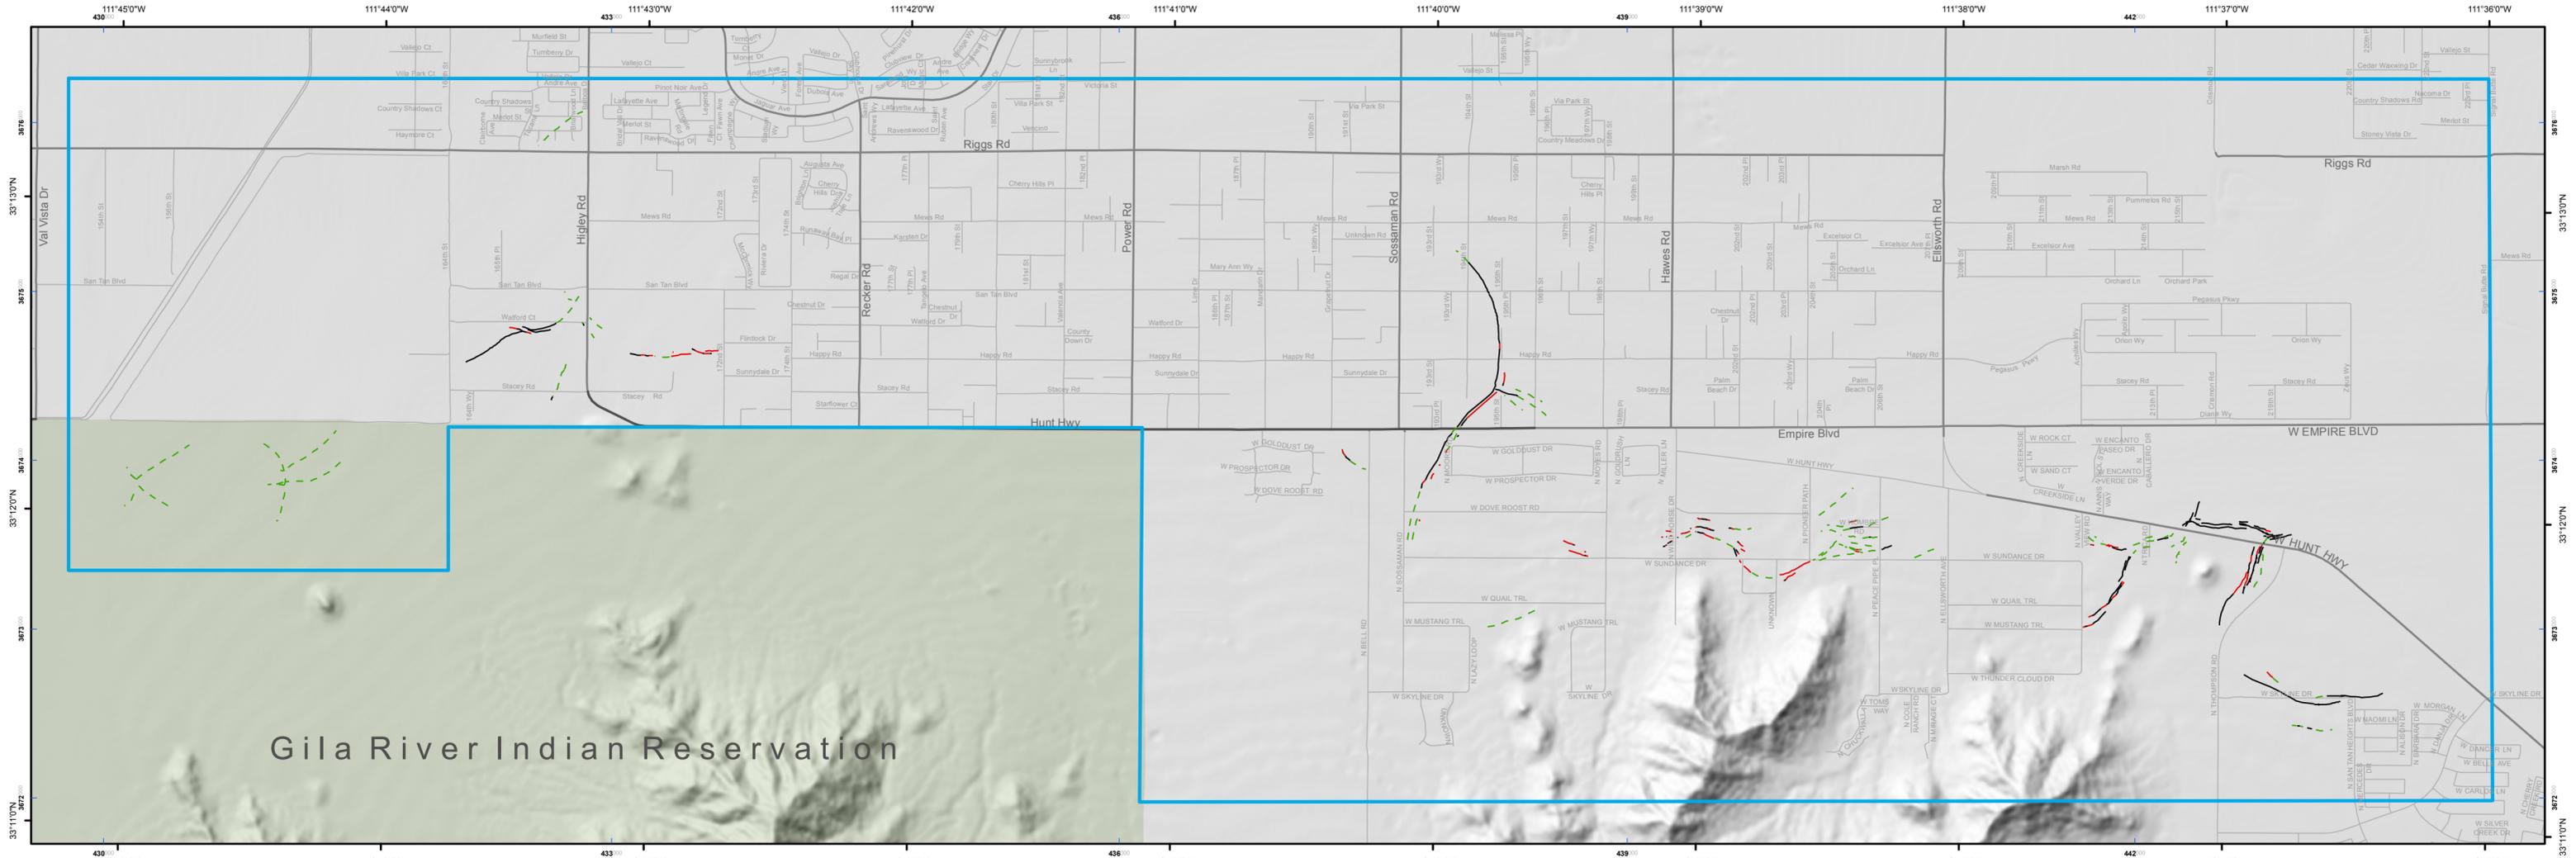
- Solid black lines represent the location of continuous earth fissures manifested as open cracks or gullies.
- Solid red lines represent the location of discontinuous earth fissures manifested as elongated to circular depressions or as abbreviated or irregular linear depressions. These discontinuous surface features frequently represent an incipient surface expression of an earth fissure.

- - - Dashed green lines represent the approximate locations of unconfirmed earth fissures, defined as fissures which could not be confirmed by surface investigations by AZGS geologists, but which have been previously reported by Professional Geologists in published documents or maps.

- The outline of the Chandler Heights Study Area is shown in blue. historical and modern aerial photos taken within this area were searched for anomalous lineaments. These lineaments were then investigated in the field to determine if there was any evidence of earth fissures.

The Gila River Indian Community is not covered by ARS 27-152.01.11, and fissures in this area were not investigated in the field as part of these investigations. Previously reported earth fissures within the Reservation boundary are represented on the map.
