# ARIZONA GEOLOGICAL SURVEY

## News Release: Release of new Maricopa County Earth Fissure Map

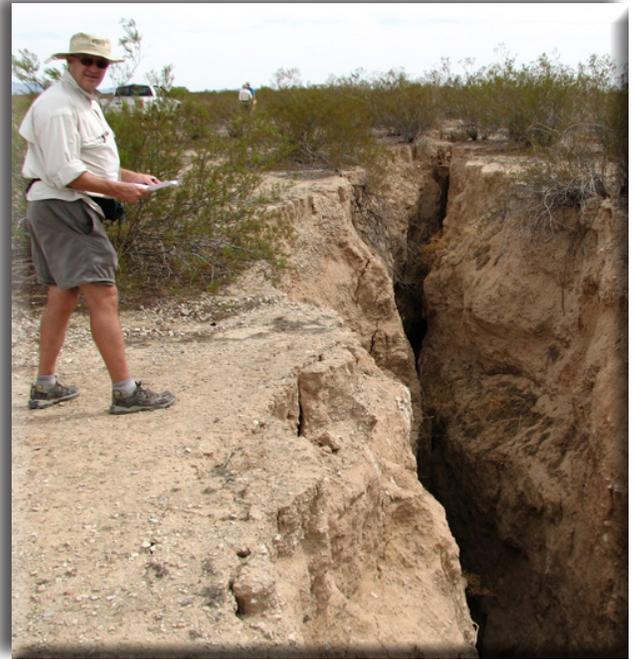
Rodgers Fissure of west-central Maricopa County circa 2007.

The largest fissure in Maricopa County is the Rodgers fissure in the Harquahala Plain near the Maricopa-La Paz county line; it is nearly 1-mile long, up to 9-feet wide, and in several places more than 45-feet deep. "Owls have been spotted nesting in the fissure and on one occasion the carcass of a cow was discovered" said AZGS geologist Joe Cook, who heads the fissure map program. For Cook's pictures of the Rodgers Fissure visit: <http://tinyurl.com/yckqcm9>

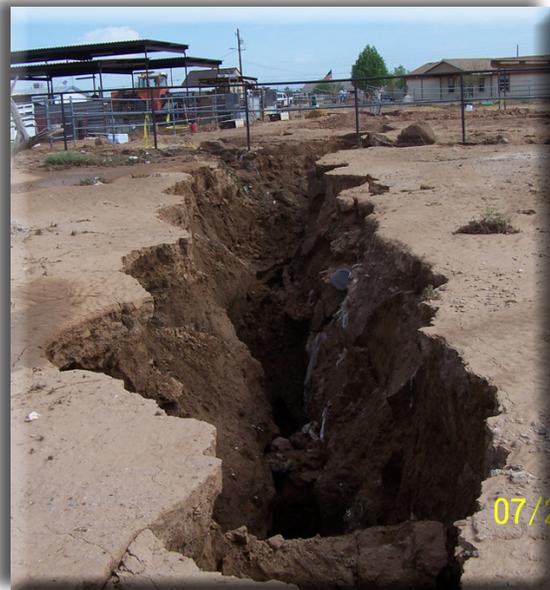
Reopening of Y-Crack fissure - 23 July 2007 - near Maricopa-Pinal County line.

The historically prominent "Y crack" fissure, which crops out near Chandler Heights on the Maricopa – Pinal County border, is the most extensive fissure network in the county. During monsoon rains in July 2007, the fissure reopened forming a crevasse 40-feet deep and 15-feet wide that damaged San Tan Blvd and Happy Road near 195th St, while engulfing and killing a horse in a corral. The fissure network, which includes segments in both Maricopa and Pinal County, is about a mile in length.
